TOWN OF GRAFTON

SUBJECT: Second Staff Review of 130 and 134 Worcester Street

Site Visit Report

Date:December 22, 2022Client:Grafton Planning BoardProject:130 & 134 Worcester RoadContractor:Page Contracting, Inc.

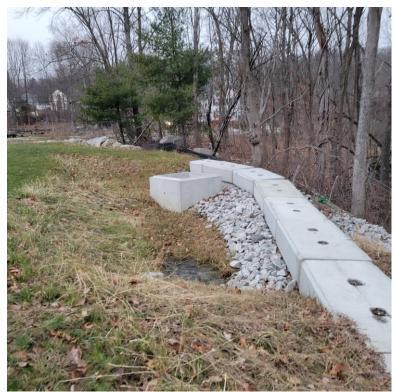
- Stormwater Basin: Depression located on the northwestern side of the site (not labelled on plans) "varies from the plan".
 - The stormwater basin was not graded in accordance with the plans, nor does it appear that it could be shaped in its current condition. Currently, the retaining wall along the northwestern side of the

site encroaches into the basin bottom and may prevent the basin from having a 3H:1V slope on the northern side of the basin. Furthermore, on the northern side of the basin crushed stone was installed along the interior basin slope in lieu of vegetation. The crushed stone creates a hydraulic connection between the impounded stormwater within the basin and the retaining wall. Photo 1 is provided below to show the retaining wall encroaching into the basin area.

Our comment remains and the contractor did confirm that the retaining wall was constructed closer to the stormwater impoundment than designed. The contractor also informed me that the design engineer believes that there is enough available area to reconstruct the stormwater basin to comply with the stormwater standards. GEI would like to reiterate that there is still a hydraulic connection between impounded stormwater within the basin and the retaining wall. This hydraulic connection will need to be addressed and eliminated by the design engineer's team during the stormwater basin's redesign.

- Outlet Control Structure: OCS-101 "to-be completed".
 - The base of the outlet control structure was installed, however the grating within the top of the structure needs to be installed.

The grating within the top of the structure needs to be installed. The contractor informed me that the grate is currently backordered.

Photo 1: Retaining wall encroaching into basin bottom and the outlet control structure (OCS-101).

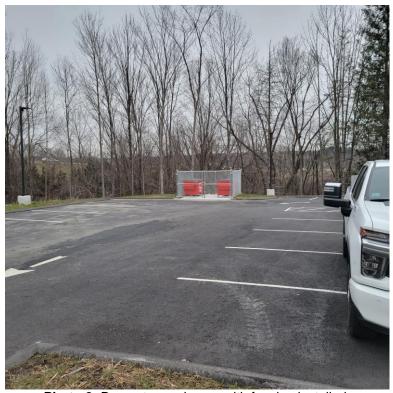
- Dumpster Pad: Dumpster Enclosure "to-be completed".
 - o The six-foot fence board screening needs to be installed.

A chain link fence has been provided at the dumpster enclosure. The contractor informed me that the fencing is required to be transparent by the CCC.

Photo 2: Dumpster enclosure with fencing installed.

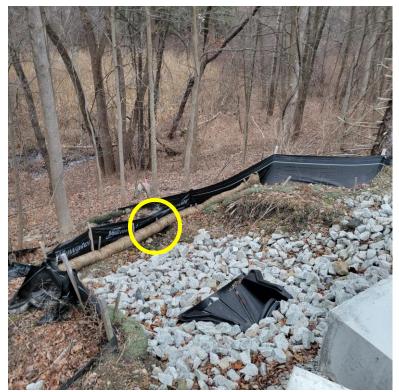
FES-01 has been installed. However, it does appear that the riprap apron for FES-01's outfall needs to be expanded to the northeast to the full apron length. Both outfalls had the previously observed sediment removed.

- Perimeter Controls: silt fence perimeter controls "to-be completed".
 - There are portions of the silt fence that are dislodged and need to be reset to operate as designed. Sedimentation was observed ±3 feet beyond the silt fence location and I would like to refer to the Decision §B.2. which states, "...discharge any pollutants or siltation into waterways or resource areas during construction...". The area where sedimentation was observed is located within the 200' RFA buffer zone. Photo 3 is provided below to show the location where the sedimentation was observed.

The perimeter controls are still in disarray and need to be reset/reestablished, however no additional sedimentation was observed. During our visit, the contractor informed me that they are hesitant to perform additional earth disturbing activities on the slope with the current frost-conditions. GEI understands the concern, however, believes less disruptive measures could be completed at FES-01 (e.g. extending riprap apron, providing additional straw wattles, etc.).

Photo 3: FES-01 installed with a refreshed riprap apron. Note: perimeter controls appear to be undermined in the encircled area.

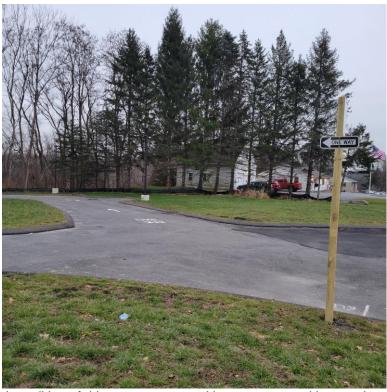
Photo 4: General condition of driveway entrance with pavement markings and temporary signage.
